Redland
CITY COUNCIL

AGENDA

GENERAL MEETING

Wednesday, 17 February 2021
commencing at 9.30am

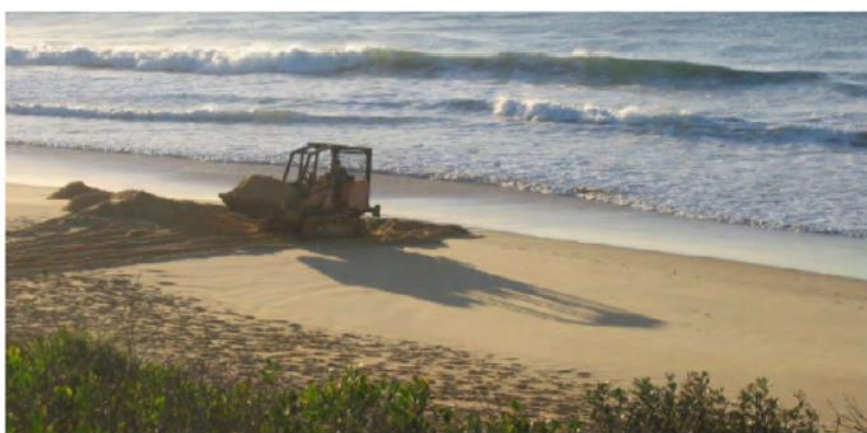
Figure 3-1 Beach Re-profilling using Mechanical Equipment (Carley et al., 2010)

Beach reprofiling, or “beach scraping”, generally involves relocating sand from the lower part of the beach to the upper beach and dune system using mechanical equipment (refer Figure 3-1 and Appendix C). The action is assumed to mimic natural beach recovery processes, albeit at an increased rate.

Beach reprofiling can be successfully used to restore beach amenity, widen the upper beach and rebuild dunes. These actions will temporarily improve the protection of adjacent assets by increasing the beach width. Such works are relatively inexpensive, can be implemented quickly and are often undertaken in response to a significant beach erosion event. The main shortcoming of beach reprofiling as an erosion control measure is it needs to be repeated frequently and may only offer limited shoreline protection.

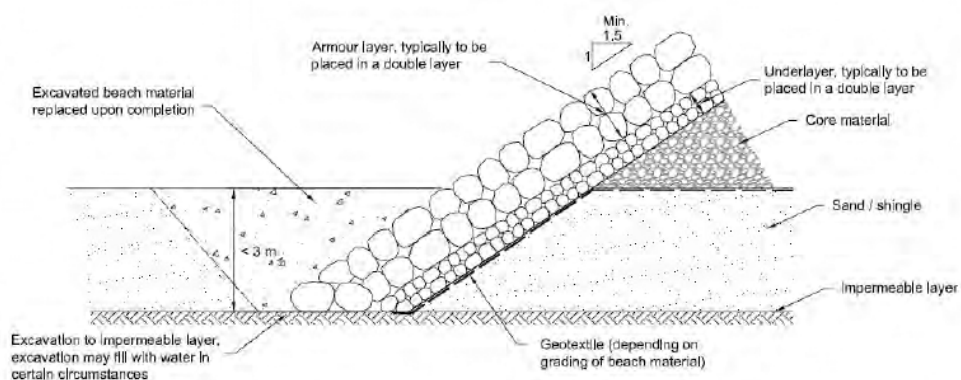
Figure 3-2 Cross-section of a Typical Rock Revetment Seawall (CIRIA, 2007)

Seawalls or rock revetments are commonly built with the intent of providing terminal protection against shoreline retreat. Seawalls are robust structures constructed along the shoreline which provide a physical barrier separating the erodible material immediately behind the structure from wave and current forces acting on the beach itself. They are typically constructed of loosely placed rock to allow for some flexible movement and need to be designed to withstand severe wave attack. Figure 3-2 provides an example cross-section of a rock revetment on a sandy shoreline with the toe of the structure down to the bedrock (impermeable layer).

Where possible, seawalls should be continuous to prevent end effects and/or discontinuities that could threaten the overall integrity of the wall. They also have to be suitably founded for stability against scour at the toe of the structure, particularly on a receding shoreline. Haphazardly placed rock and/or the use of inappropriate materials intended to provide shoreline erosion protection can have the opposite affect by accelerating the erosion problem.

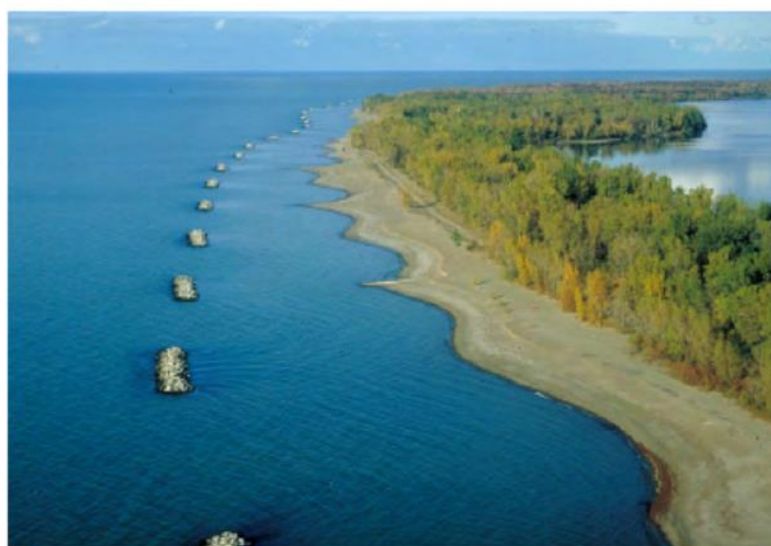
Figure 3-3 Offshore Breakwater Series and Salient Formation (U.S. Army Corps of Engineers, 2002)

Emergent offshore breakwaters (with crest level above the water surface at some or all stages of the tide) are commonly used to reduce wave induced beach erosion in the United States, Europe and Japan. Offshore breakwaters are typically constructed parallel to the shoreline and slightly seaward of the surf zone. The structure is intended to dissipate part of the incident wave energy and reduce the direct impact of storm waves. Under prevailing conditions, the presence of a breakwater will modify wave, flow and sediment transport patterns in the lee of the structure may promote the growth of a shoreline salient or tombolo. This effectively widens the target area of the beach and provides an additional erosion buffer. Offshore breakwaters are often constructed in a series to protect long sections of coastline, similar to a groyne field however with the advantage of not completing blocking longshore sediment transport (unless tombolos form).

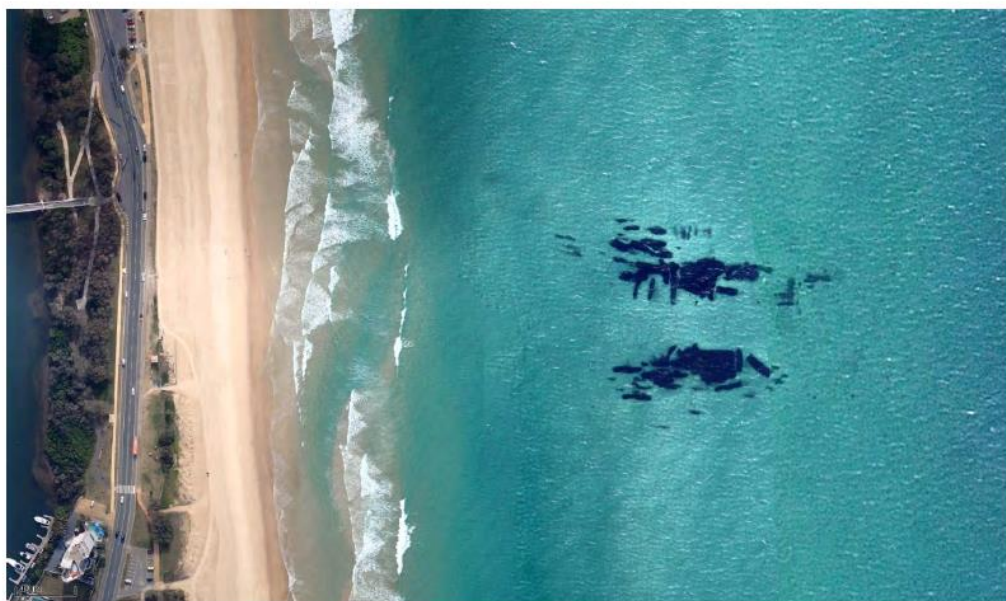
Figure 3-4 Geotextile Sand Container Artificial Reef at Narrowneck, Gold Coast (Source: NearMap, 2011)

sediment transport patterns and can lead to the formation of a salient in the lee of the reef and therefore widens the beach. In this regard, a submerged artificial reef is intended to function in a similar way to an offshore breakwater (noting that the crest of a traditional breakwater is above the water surface). Some submerged reefs, such as 'The Twins' at Narrowneck on the Gold Coast (see Figure 3-4), attempt to combine shoreline protection with recreational surfing and/or snorkelling/SCUBA diving benefits and are referred to as 'multi-purpose submerged reefs'. Submerged reefs don't intrude on the beach and have the advantage of low visual impact. Consequently, the scenic amenity of an area is not altered.

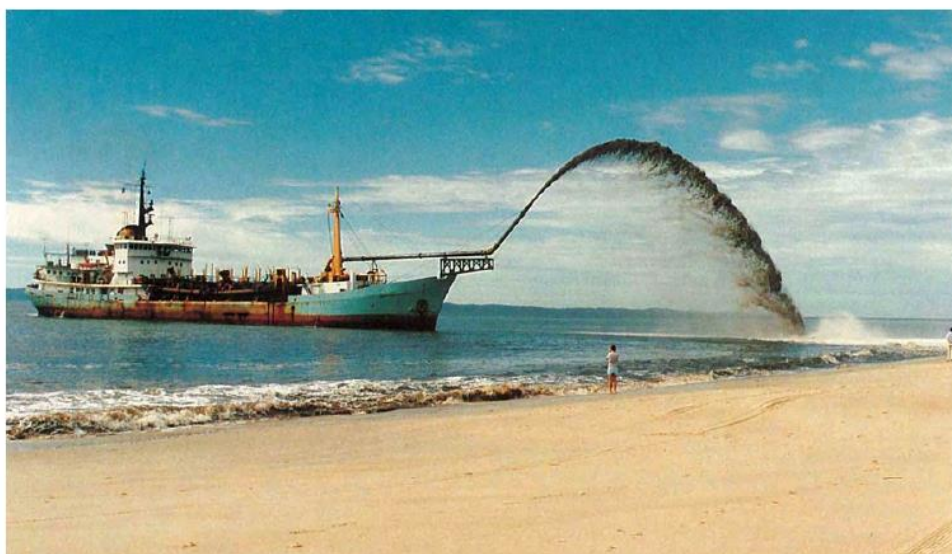
Figure 3-5 Nourishment Sand being Delivered ‘over-the-bow’ to Woorim Beach

Port of Brisbane Pty Ltd maintenance dredge material is currently used by Council to nourish the beach at Woorim (refer Figure 3-5).

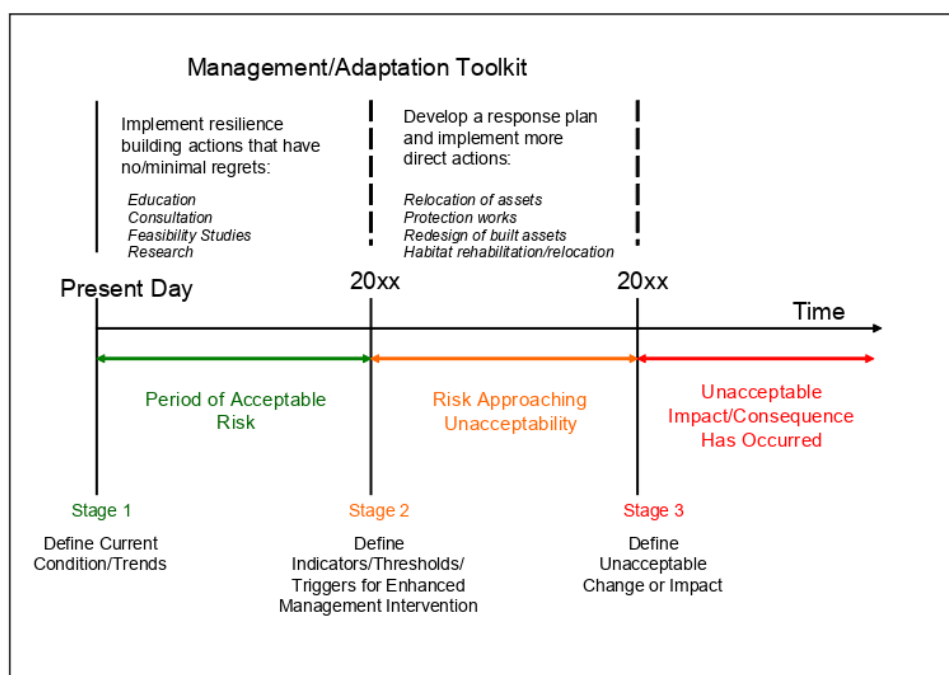
Figure 3-6 Application of Adaptation Actions along the Climate Change Risk Continuum

The tool can help decision-makers align perceived risk to infrastructure with the selection of the most appropriate adaptation measures and actions. In this regard, the tool is not limited to only climate change studies but can also be used to guide more immediate shoreline planning and management decisions. The tool is illustrated in Figure 3-6.

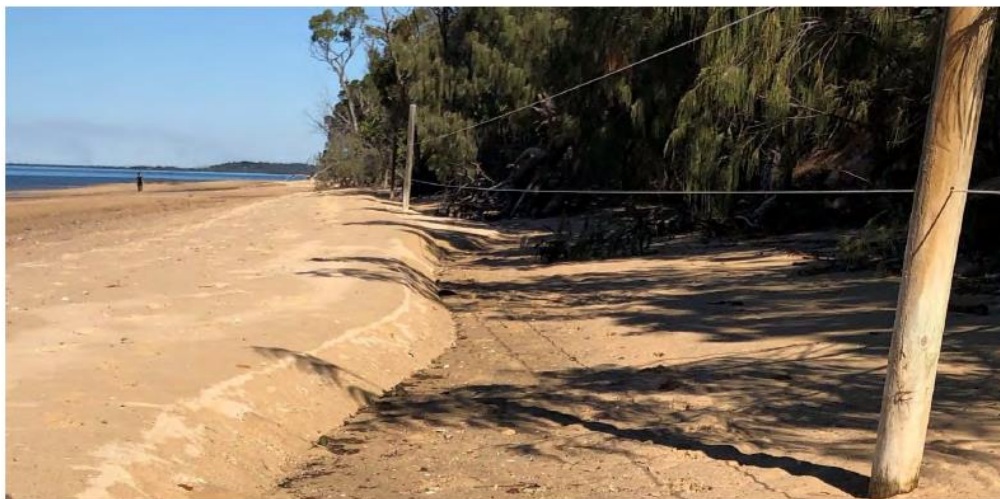
Figure 4-1 Active beach recovery, Norfolk Beach, July 2020

Based on this information it is apparent that there has been recent unaddressed storm erosion on Norfolk Beach. However, photos taken by BMT in July 2020 (see Figure 4-1 and Appendix F) show active beach recovery and significant recovery of the beach is likely given sufficient time. As concerns have been raised by community members that if no action is taken erosion will be exacerbated by future storms, remedial action is recommended to accelerate recovery of Norfolk Beach and provide a greater buffer against future events. This is discussed further in section 6.3.5 and section 8.

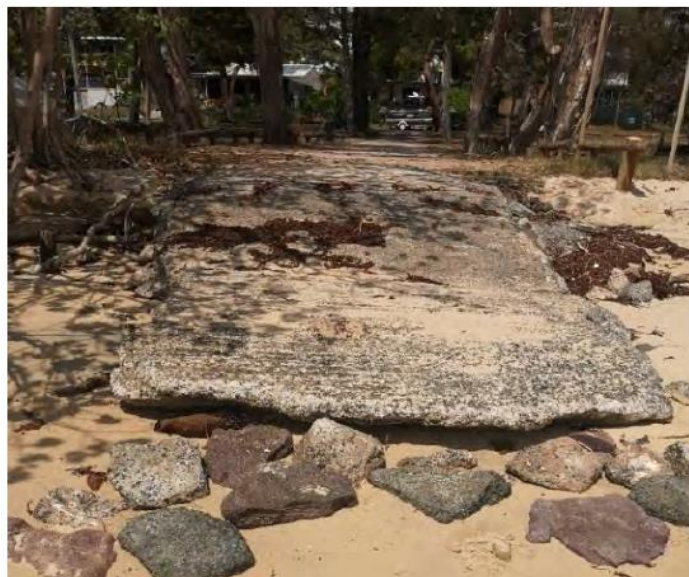
Figure 6-2 Morwong Beach Boat Ramp, March 2019

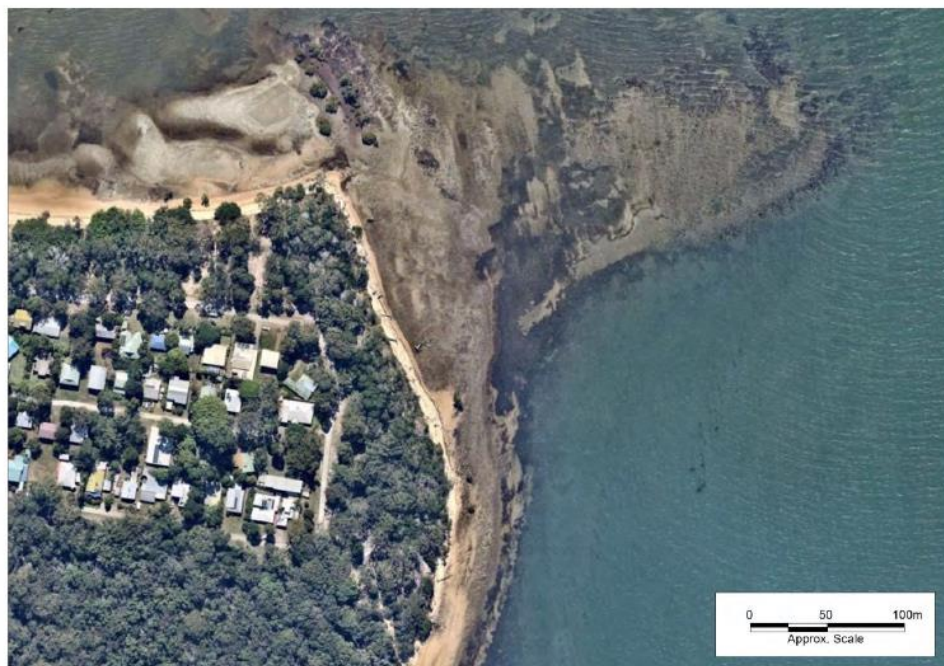
Aerial photographs from 1955 and 1997 show the rock outcrop connected to Morwong and Norfolk beaches by a sand spit forming a tombolo. Loss of vegetation on the rock outcrop and sand spit occurred between 1955 and 1997, with subsequent erosion of the connecting spit occurring between 1997 and 2013. Aerial photography indicates erosion of up to approximately 20 m since 1955. Minimal change in the vegetation line has occurred in the vicinity of Control Point 4 at the southern end of the beach segment.

Figure 6-3 North-eastern Norfolk Beach (Nearmap 2020)

It is not known what occurred historically at this location to cause such a dramatic change in the shoreline. It is likely to have either been a significant storm causing immediate change or a slow progression of natural processes which reached a breaking point. The area is complex with both north and east facing beaches and an extensive offshore shoal. The wave actions and currents during a storm event such as ex-TC Oswald would be complex and not able to be modelled in detail without extensive focused data collection and significant calibration. This lack of detailed knowledge

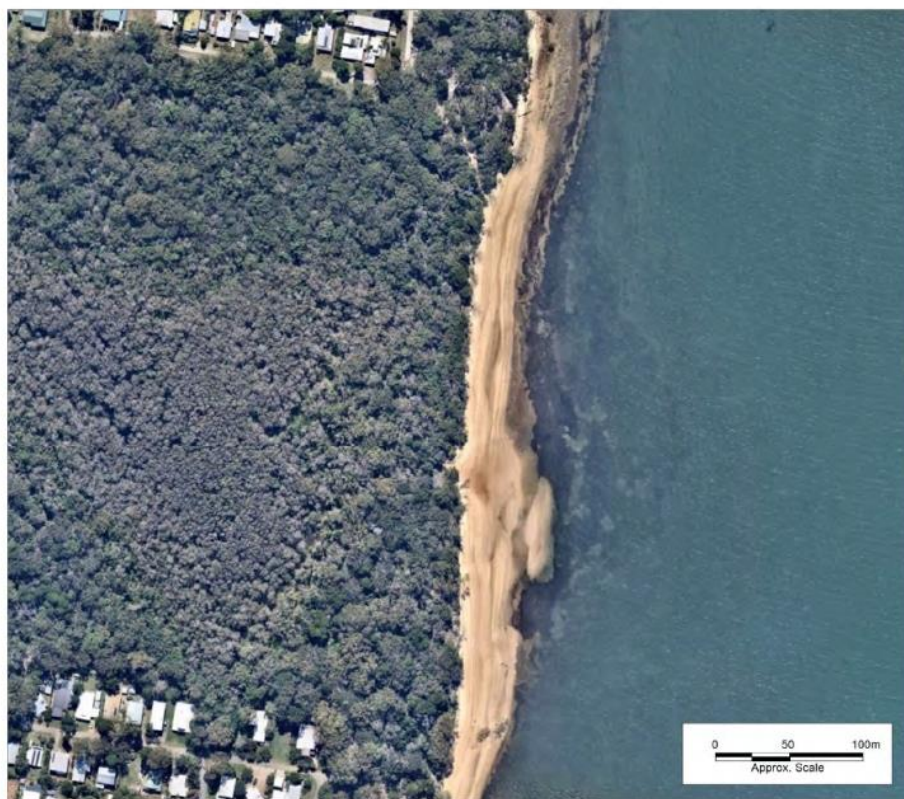
Concern has been raised by the community regarding the potential for saltwater intrusion into the wetlands if the current dune is breached or overtopped. Monitoring is needed to determine whether this is a seasonal or a longer-term trend. It is likely that fresh water outflow after heavy rain will erode the dune, allowing salt water intrusion until natural processes again close the entrance, as shown occurring in Figure 6-5. If a longer-term trend is indicated then the underlying physical process change will need to be identified before a mitigation action can be formulated.

Figure 6-5 Melaleuca Wetland and beach (Nearmap 2020)

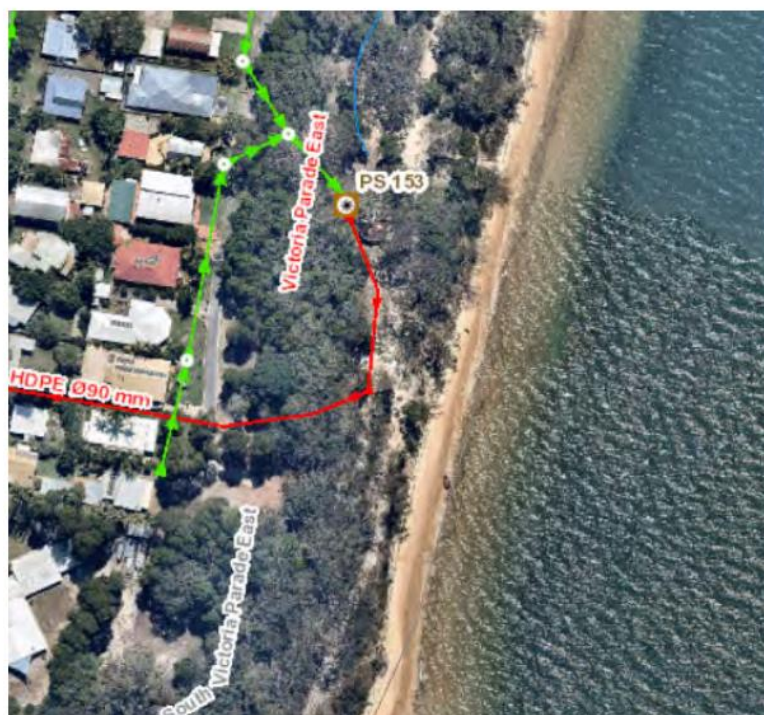
Figure 6-6 Sewer pipe and pump station, Norfolk Beach (Red-e-Map, 2020)

Community members have reported stormwater run-off collects in the trench of the James Street sewer line and discharges onto the beach from under the northern geotextile seawall. As this is a drainage/sewer issue and located well behind the beach this issue needs to be investigated by Council.

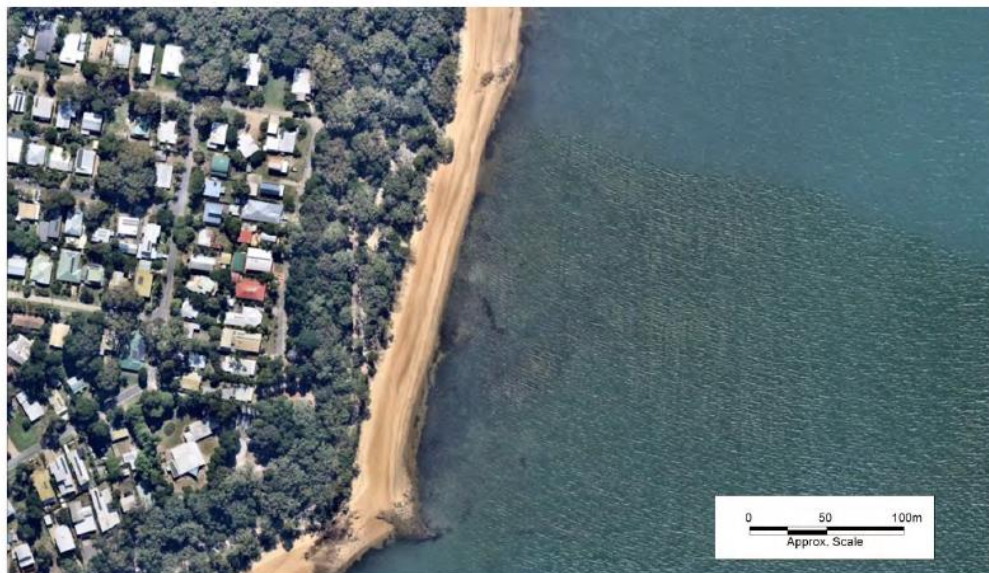
Figure 6-7 Norfolk Beach fronting Victoria Parade East (Nearmap 2020)

BMT has been requested by Council to make recommendations regarding the existing unapproved existing geotextile container seawalls, constructed as an emergency measure to protect trees. While not currently causing any interruption to coastal processes, such as exacerbating erosion at the end of the structures, the protective role of these structures is minimal as the beach in front of the seawalls has subsequently recovered, as shown in Figure 6-8 and Figure 6-9 below. It is noted that while the walls have strong support from some members of the community overall opinions are mixed, as evidenced by feedback received on this project.

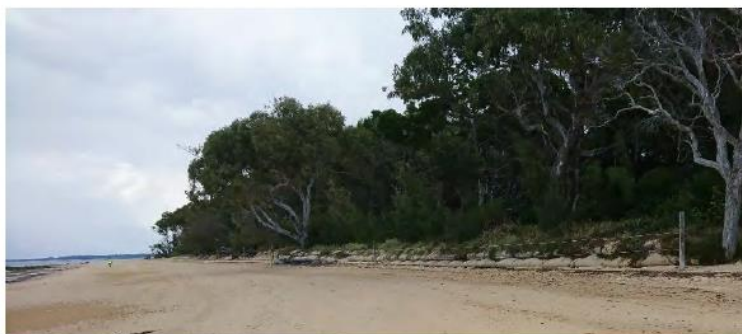
Figure 6-8 Northern geotextile container seawall - October 2018

While there is a cost associated with removal it should be noted that the design life expectancy of a geotextile structure is in the order of 15-20 years and the structure will require removal or replacement at some time in the future.

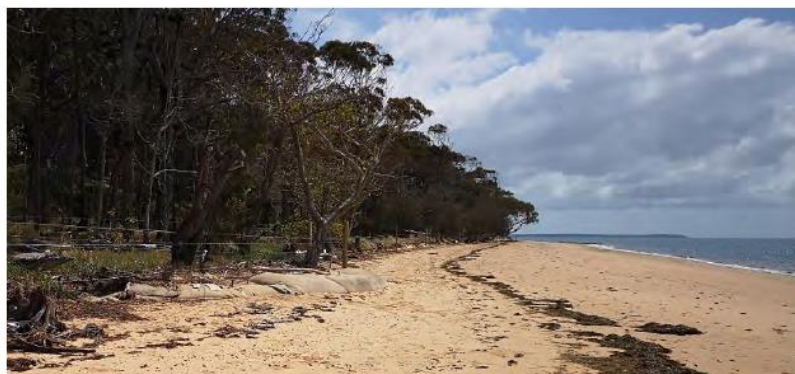
Figure 6-9 Geotextile container seawall Norfolk Beach - March 2019

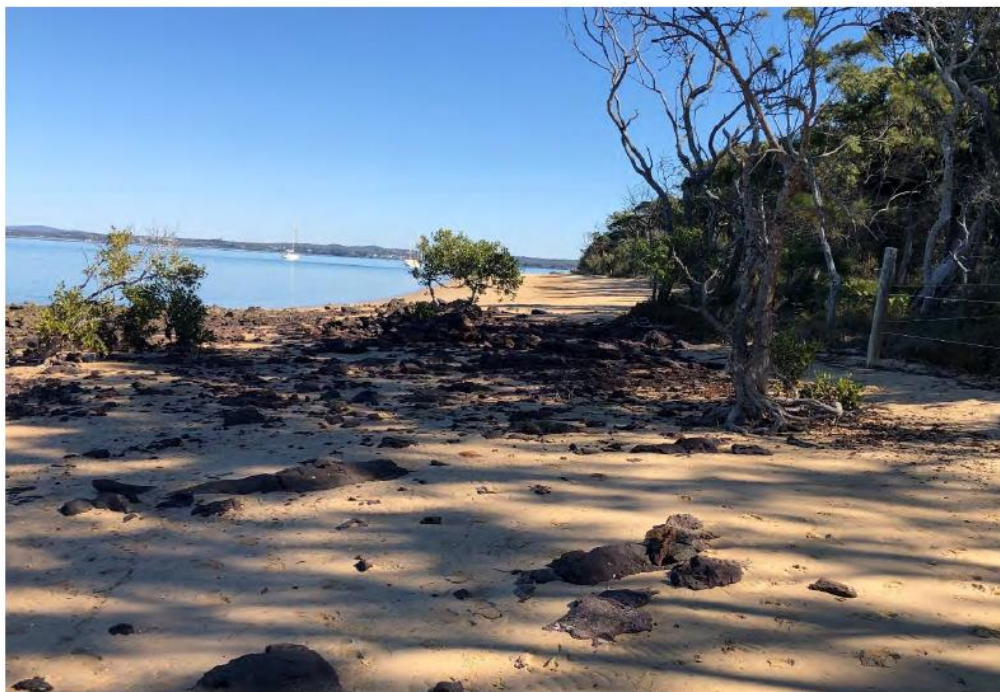
Figure 6-11 Control Point 2 (looking south-west), July 2020

While the use of geotextile containers for dune enhancement or reinforcement of control points 1 and 2 has been included in the MCA it is not recommended at this stage. This option refers to specifically to structural reinforcement of the dune and not ongoing vegetation management and enhancement activities, which it is hoped will continue. Recent photos from July 2020 (BMT) shown in Figure 6-11 and Appendix G do not indicate severe erosion to warrant this type of intervention at this time as broader beach nourishment is recommended.

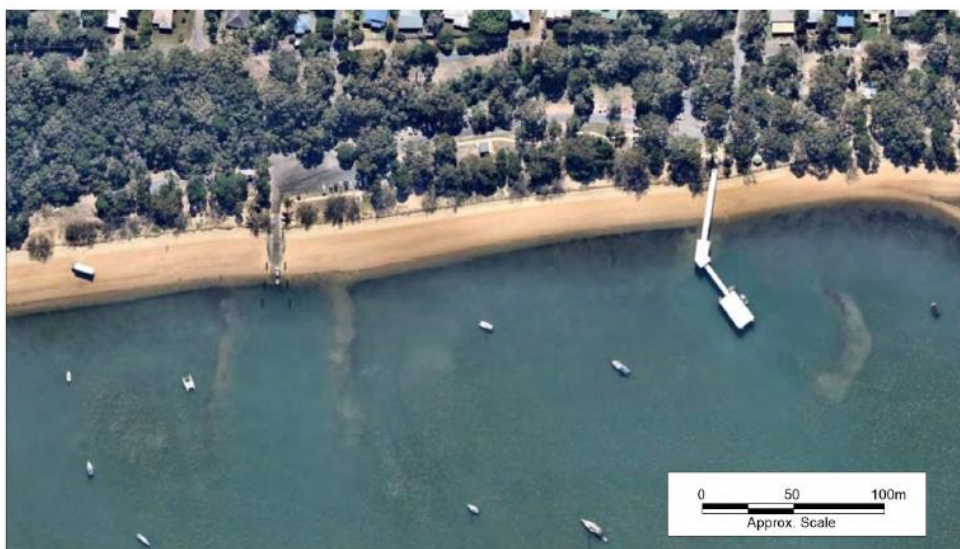
Figure 6-13 Main Beach between Ferry Terminal and Barge Ramp (Nearmap 2020)

Aerial photography indicates an accretion of up to 12 m from 1997 to 2018. The barge ramp upgraded in 2018 and has had accumulations of sand on its eastern edge since completion.

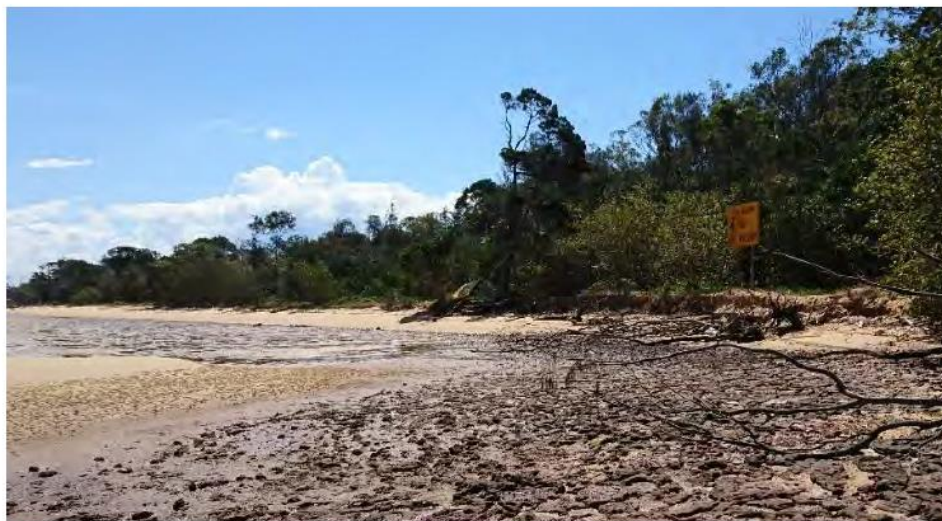
Figure 6-16 Main Beach fronting the Golf Course - fallen warning sign in the centre of the photo (October 2018)

There also appears to be some issues with cable and electric wires and associated warning signs being inadequately maintained by the appropriate agencies (Figure 6-16).

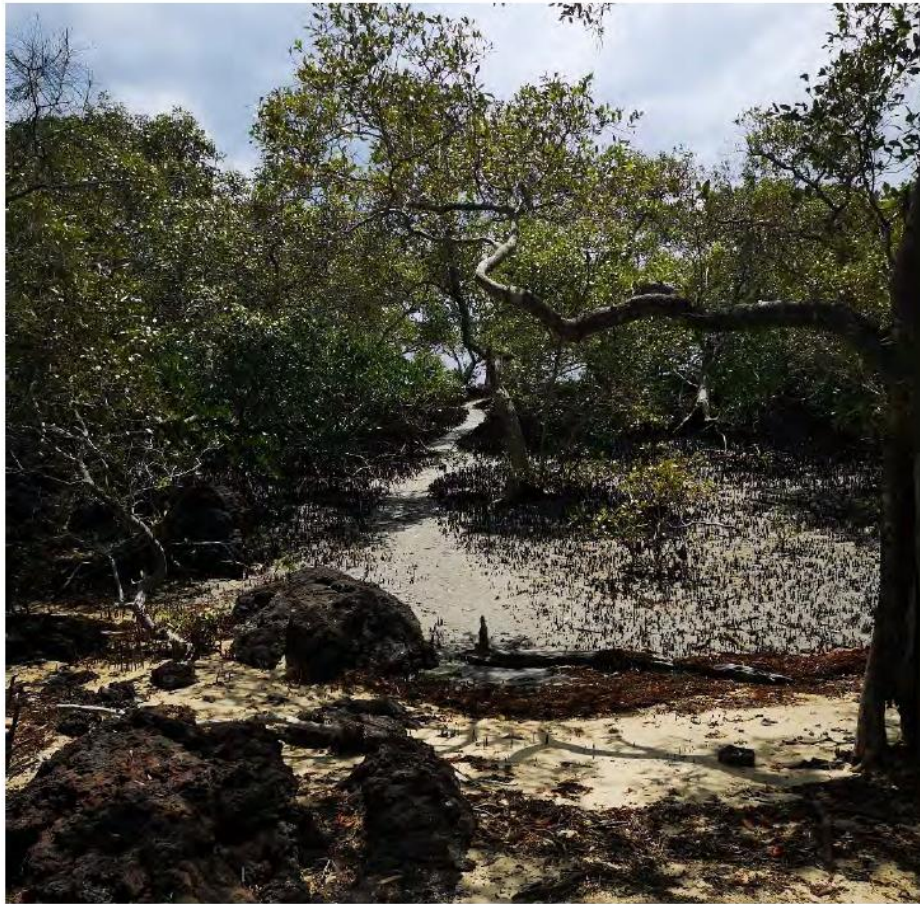
Figure 6-18 Track through mangroves

There are a couple of ad hoc boat/kayak tracks through the mangroves, one of which is shown in Figure 6-18. The tracks appear to be well defined with the lack of vegetation suggesting frequent use, however as the surrounding mangroves appear healthy and undamaged these are not considered cause for concern at present. Any intensification of use is likely to cause further damage. Similarly for the walking track which does not appear to be heavily used at present but may result in damage to the surrounding vegetation if the use intensifies.

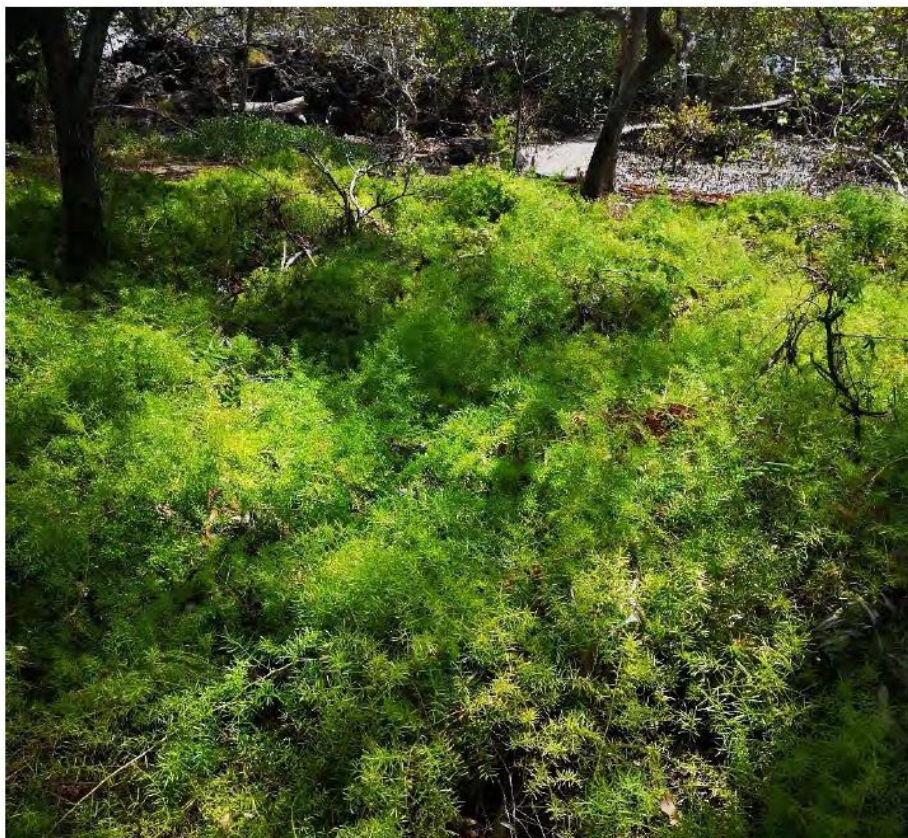
Figure 6-19 Invasive weed (Ground Asparagus)

Large patches of invasive plants are present, including Ground Asparagus (*Asparagus aethiopicus*), shown in Figure 6-19. An Integrated Weed Management Plan for Coochiemudlo Island (Ecosure, 2017) was prepared for Council and contains recommendations for weed management and monitoring.

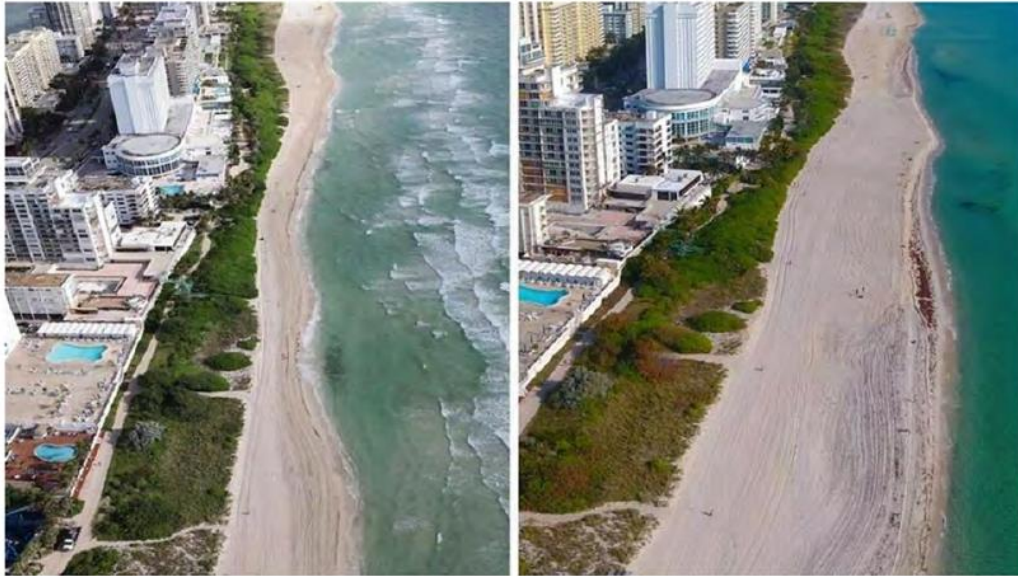
Figure C-2 Beach nourishment before (left) and after (right)

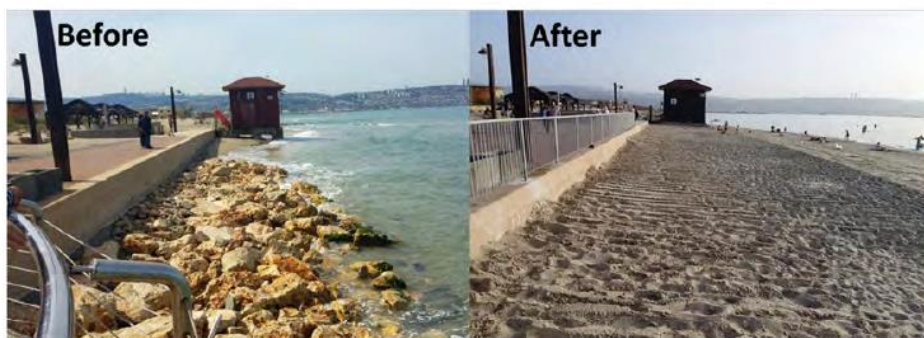
Figure C-3 Beach nourishment before (left) and after (right)

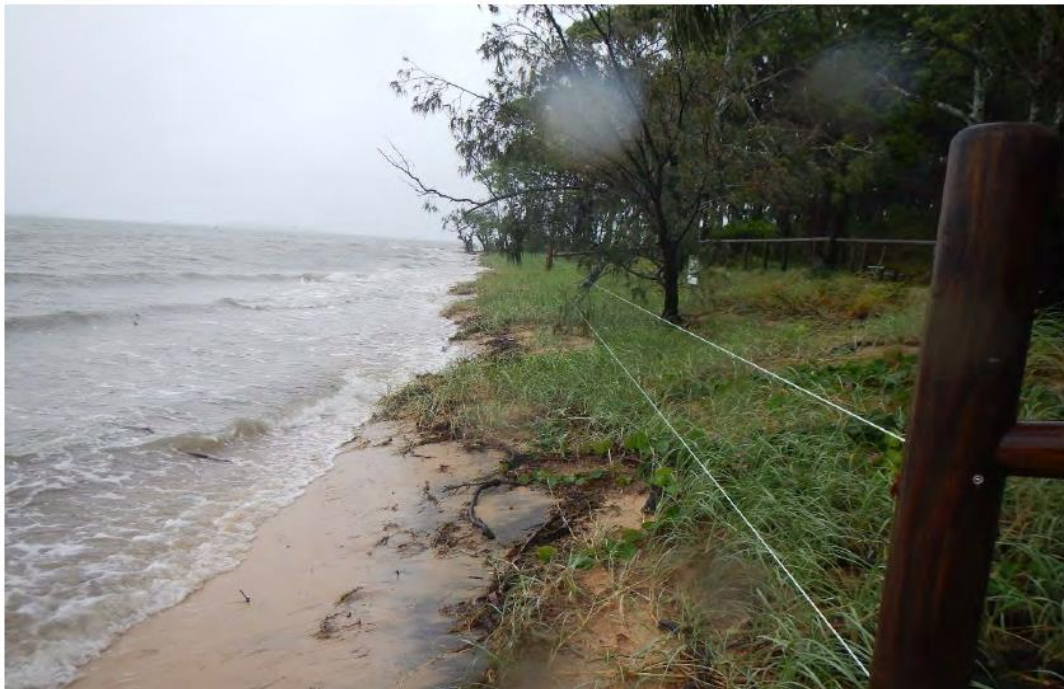
Looking towards CP2 from the southern access to the Heritage precinct, Norfolk Beach - 5 May 2015. Note width of vegetated dune

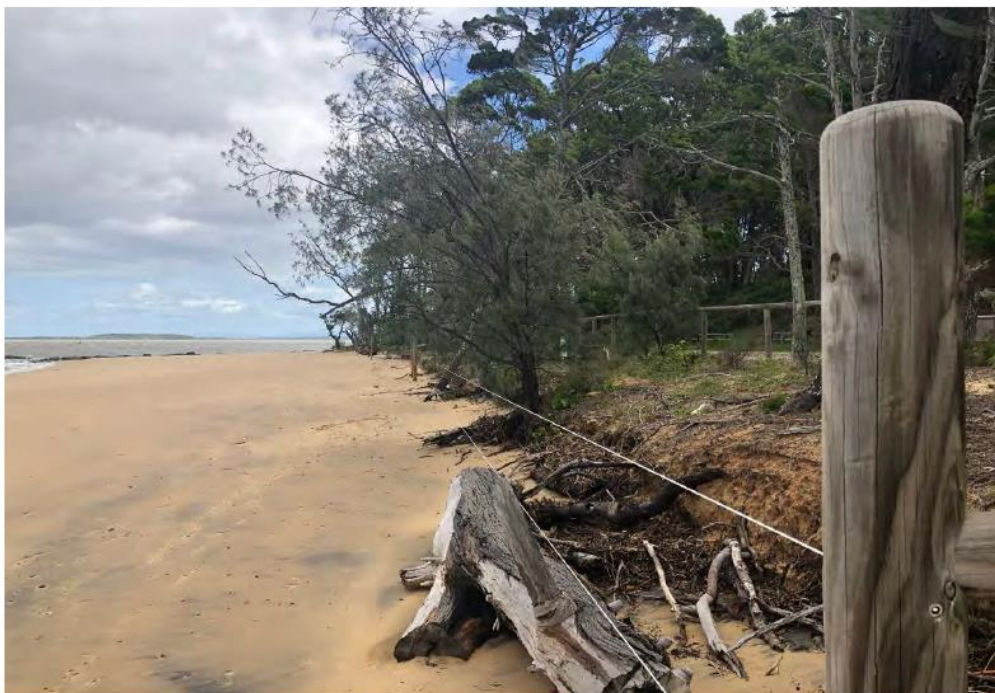
Same spot 11 March 2020 – Note erosion & this is the least eroded section on Norfolk Beach today

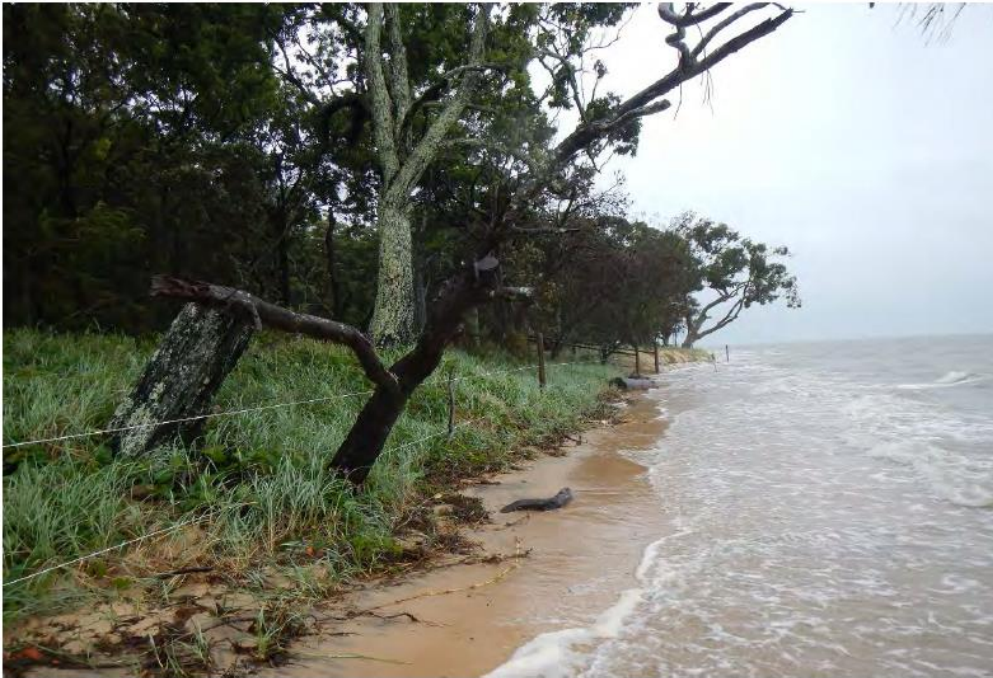
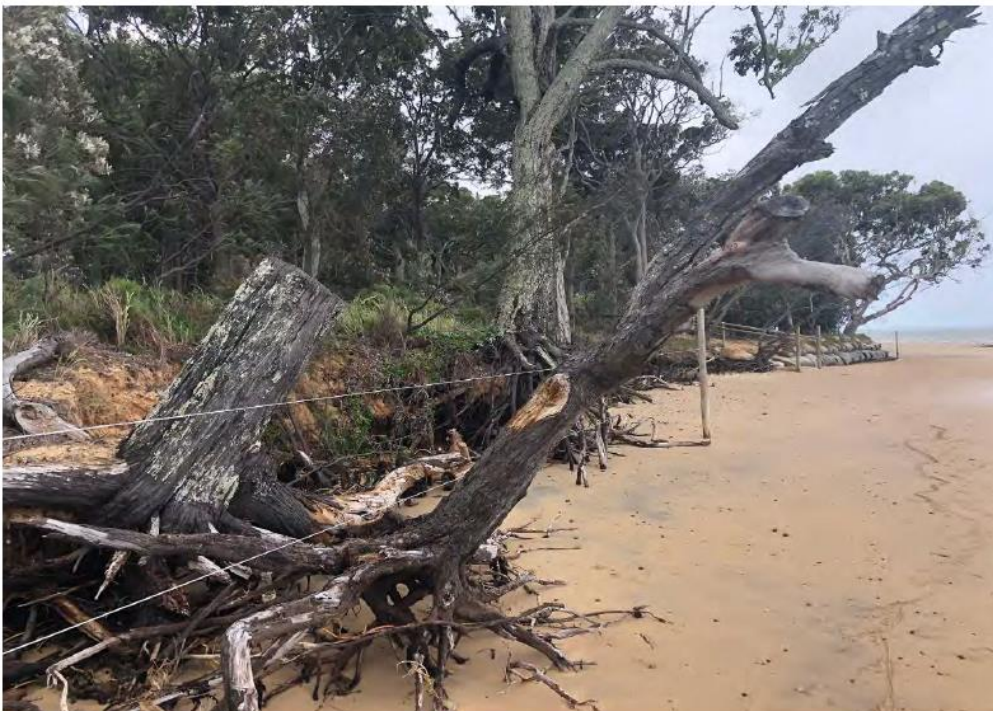
Looking north to CP3. Compare the top photo from May 2015 to the bottom, 11 March.2020 -
Note the loss of vegetated dune , particularly in front of the fence line

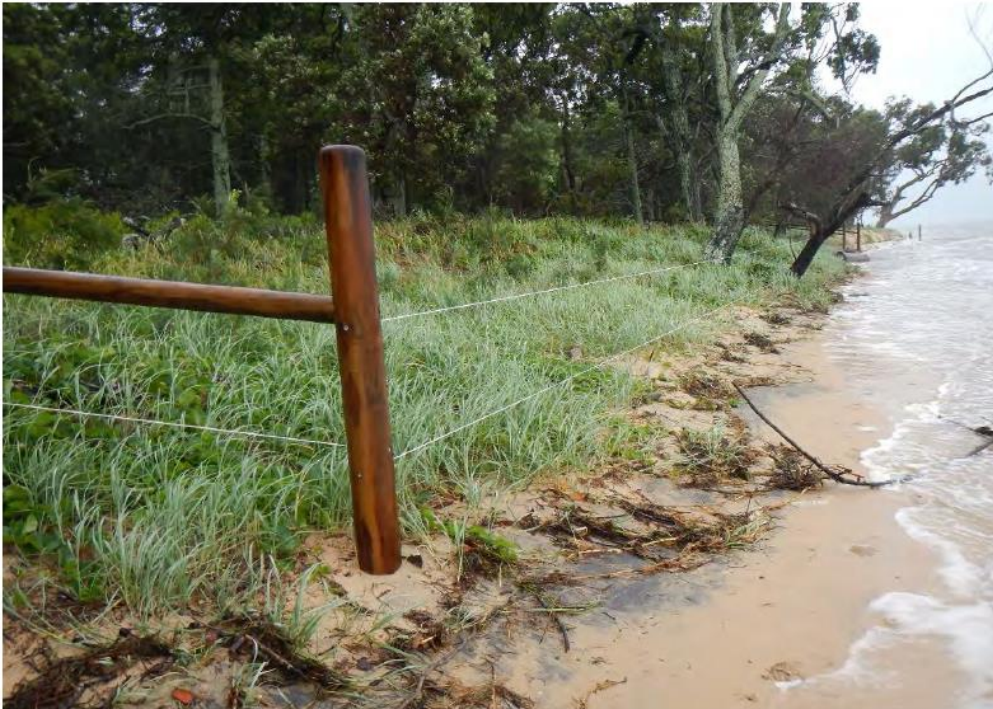
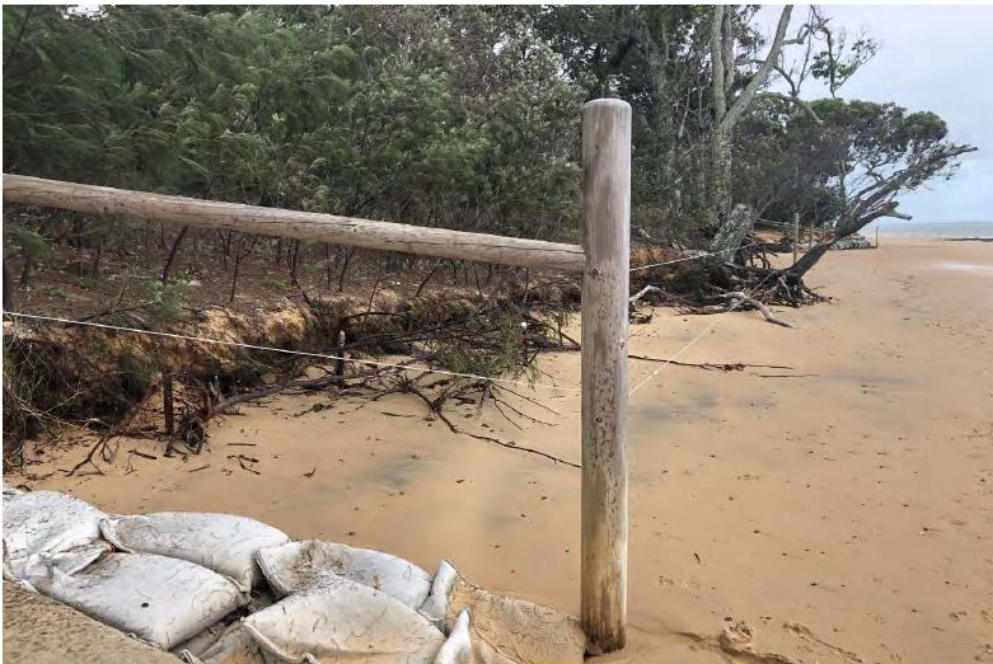
Northern access to Heritage precinct looking north – note top photo from 3 May 2015 lush vegetated dune compared to the eroded scarp 3 metres from the fence-line yesterday - 11 March 2020

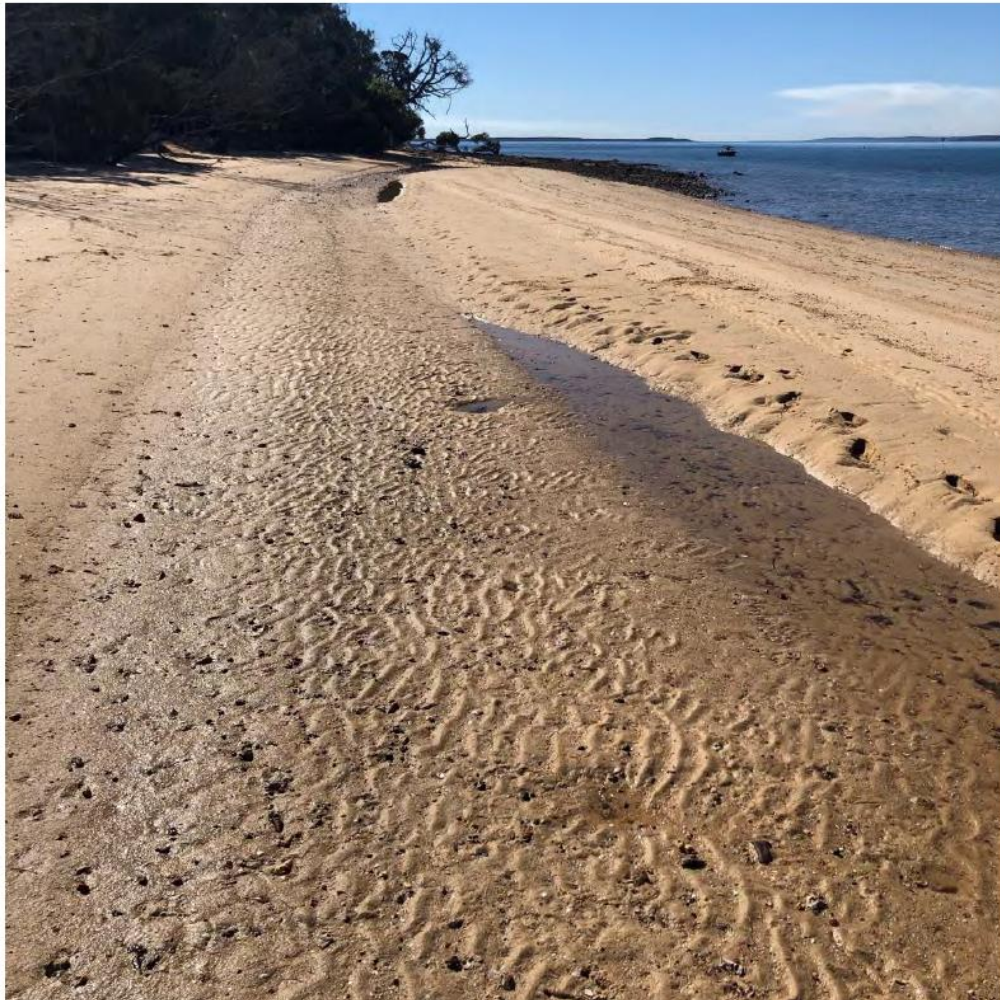
Figure F-7 Beach recovery (Melaleuca Wetlands looking north to Control Point 4)
